SPECIAL REPORT : SR99/006

Tensile Testing of Safety Line

Client : NSW Police Service
NSW Water Police Branch,
Wharf 25
Harris Street
PYRMONT NSW 2009.

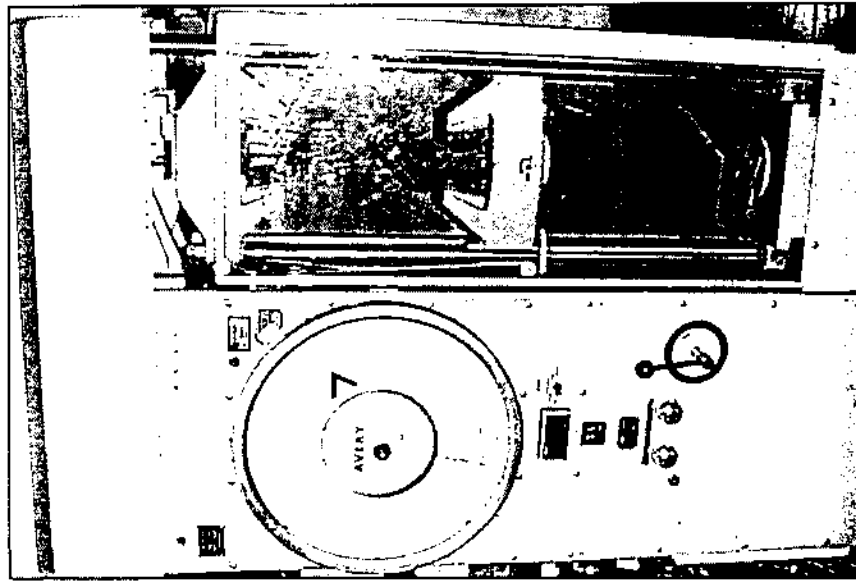
Photograph 1.

Crashlab is NATA registered for tensile testing of webbing to Australian Standard AS 1753. The test methodology and procedures used for the testing of webbing to AS2227 are the same as those used for the tensile testing of seat belt webbing to AS1753. Testing was conducted on an Avery Tensile Tester, Type No. 7108 DCN, Machine No. E70421, and identified by Crashlab equipment number of TCL 474. Refer to Photograph 1 in Appendix B.

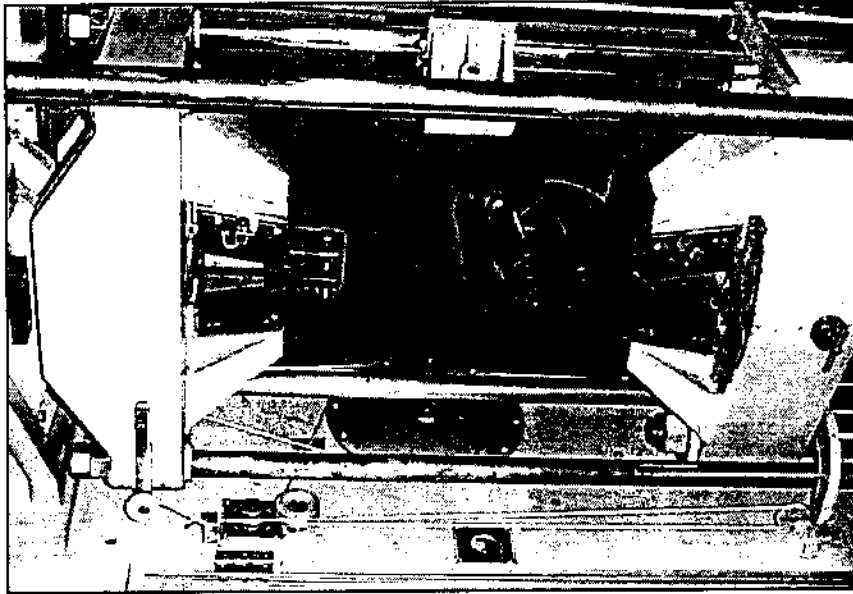
Photograph 2.

The hook was attached to a fixture at the top head of the Avery and the webbing end was threaded through the Bollard grip on the bottom head. Refer to Photograph 2 in Appendix B.

The Avery Tensile Test machine was used to apply a static load to the specimen. A maximum load of 6 kN was achieved prior to failure of the stitch pattern. Refer to Test Results Details in Appendix A.

The hook used in Test G90096 was removed from the specimen and the other hook replaced on the untested end of the safety line. This hook was attached to a fixture at the top head of the Avery and the webbing end was threaded through the Bollard grip on the bottom head. Refer to Photograph 2 in Appendix B.

The Avery Tensile Test machine was used to apply a static load to the specimen. A tensile failure load of 6.4 kN was recorded for this test and the mode of failure was the stitch pattern. Refer to Test Results Details in Appendix A.

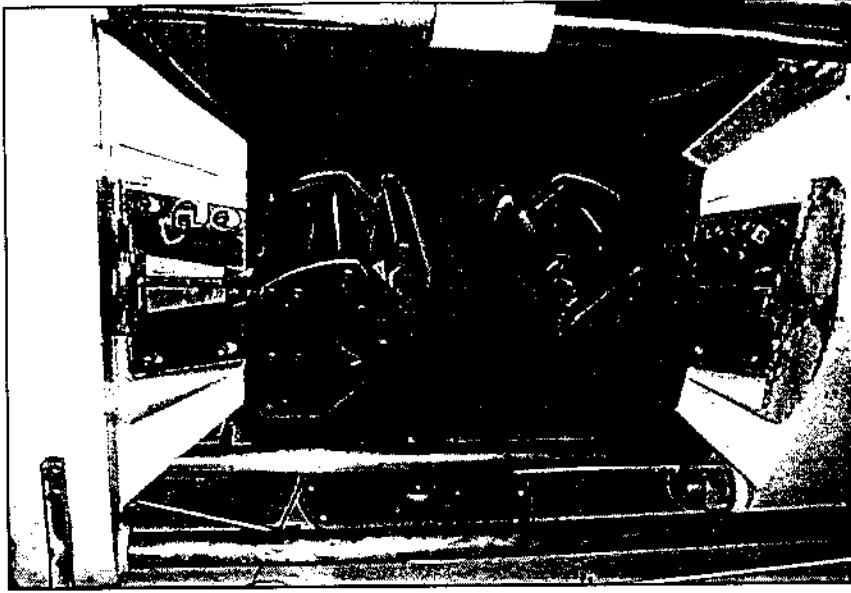
Photograph 3.

The webbing from the specimen was threaded through the Bollard grips, which were used in both the top and bottom heads of the Avery. Refer to Photograph 3 in Appendix B.

The Avery Tensile Test machine was used to apply a static load to the specimen. A tensile failure load of 16.6 kN was recorded for this test. The webbing failed in the central region of the specimen away from both Bollard grips. Refer to Test Results Details in Appendix A.

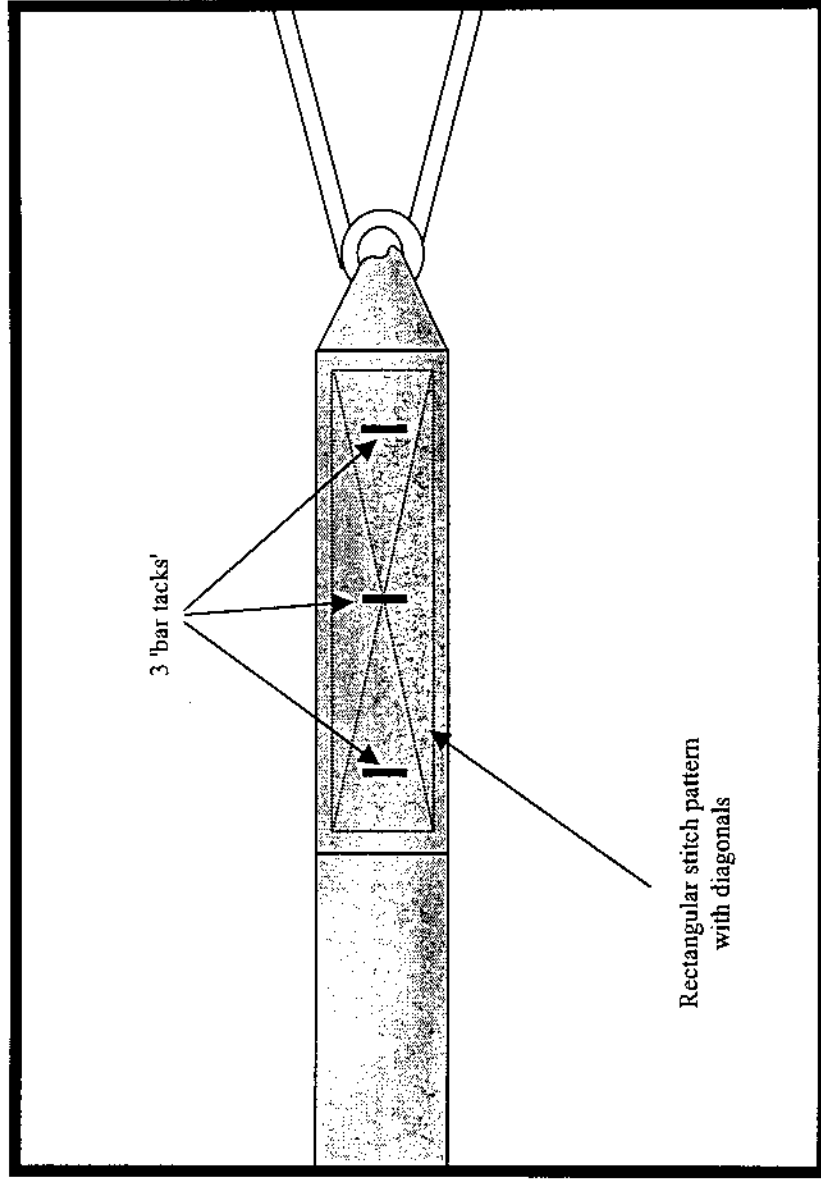
Sketch of the stitch pattern

The safety line consisted of a length of webbing with hooks attached at both ends. The hooks were retained by the webbing being folded through an eye in the hook and then stitched in place. Two coloured threads were used, a yellow thread was used for the three stitched 'bar tacks' and a red thread used for the large rectangular stitch pattern with diagonals. The red thread appeared to be thinner than the yellow thread and similar to thread that is usually used for attaching labels. Refer to Sketch in Appendix C.

The stitching failed without significant damage to the webbing, which is unusual. A stitched joint, other than that used to attach labels or for decorative purposes, typically causes significant damage to the webbing during failure. The lack of webbing damage tends to suggest that either the stitching had weakened significantly from its manufactured strength or that the stitch pattern was significantly weaker than the strength requirements of AS2227.
